## **SMUD Thornton On-Site Review**

The SMUD Thornton Avenue former electrical substation is located at 1610 Thornton Avenue, Sacramento, California, and is identified in DTSC records as EnviroStor Site: 60002764. DTSC's current project documents describe it as a former electrical substation on an approximately 0.29-acre parcel in a light industrial/commercial area.

### **Technical Advisor On-Site Review**

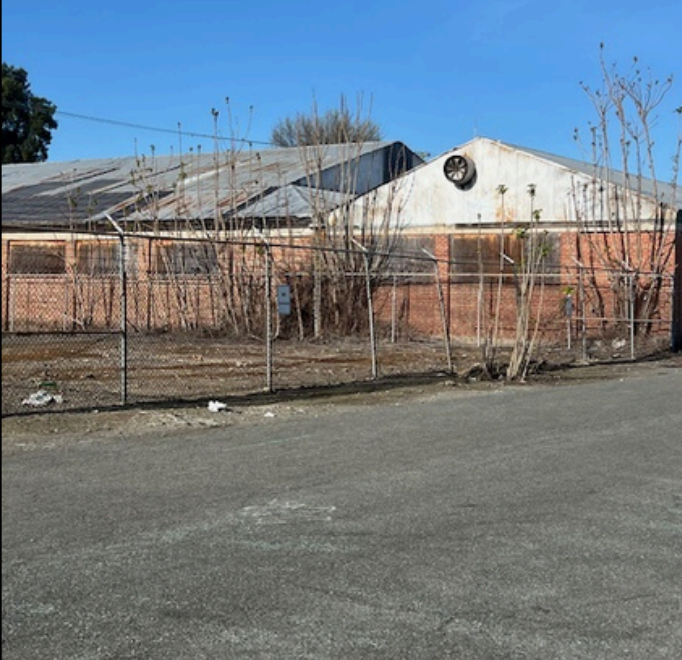
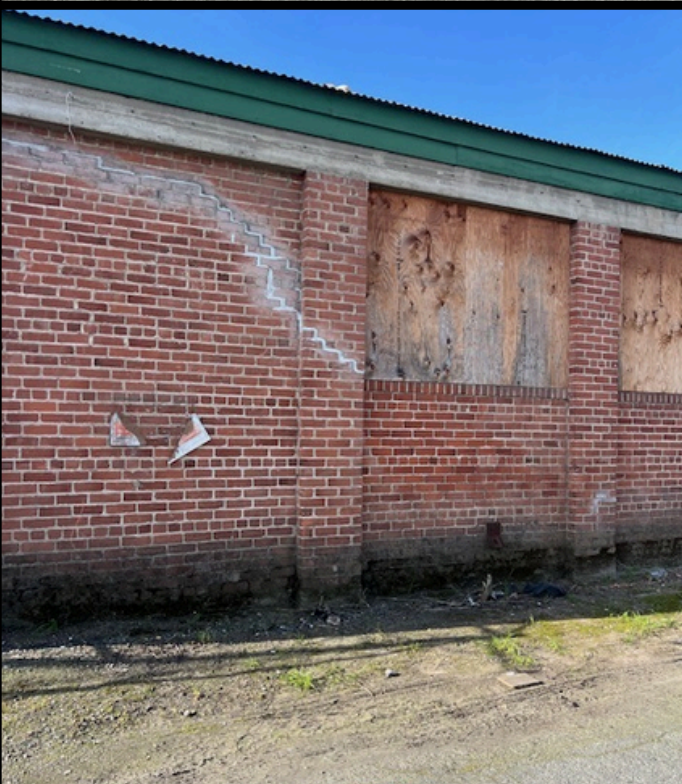
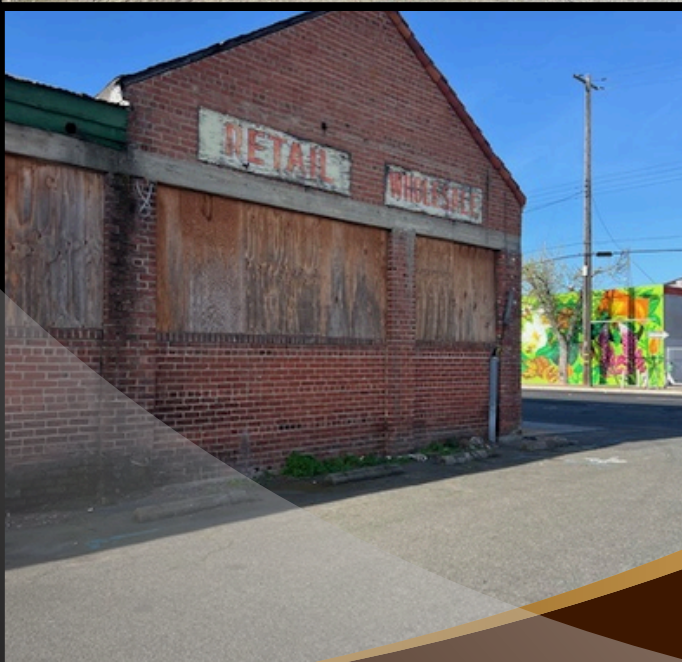
The site presents as a vacant, fenced, aging industrial property with a visibly deteriorated built environment. The dominant structure is a long, low industrial building with red brick walls, boarded window openings, and a large weathered corrugated metal roof showing extensive rust staining, patchwork repairs, and surface wear. The Technical Advisor site review saw portions of the building enveloped in visibly poor condition, including aged siding, discoloration, and localized cracking in masonry along the exterior wall. The structure appears unused and secured against entry.

The parcel itself looks largely bare and unlandscaped, with a mix of compacted dirt, gravelly surface conditions, sparse vegetation, debris, and scattered volunteer plant growth near fencing and

wall lines. A chain-link fence topped with barbed wire surrounds much of the property, reinforcing the impression that the site is closed off from public access. There are also visible paved areas around the perimeter, including roadway or parking surfaces adjacent to the fenced lot. One facade retains faded painted signage reading “Retail” and “Wholesale,” suggesting long-standing industrial or warehouse-style use in the area.
